REPORT 77-31

Roof moisture survey

Ten State of New Hampshire buildings

ROOF MOISTURE SURVEY: TEN STATE OF NEW HAMPSHIRE BUILDINGS

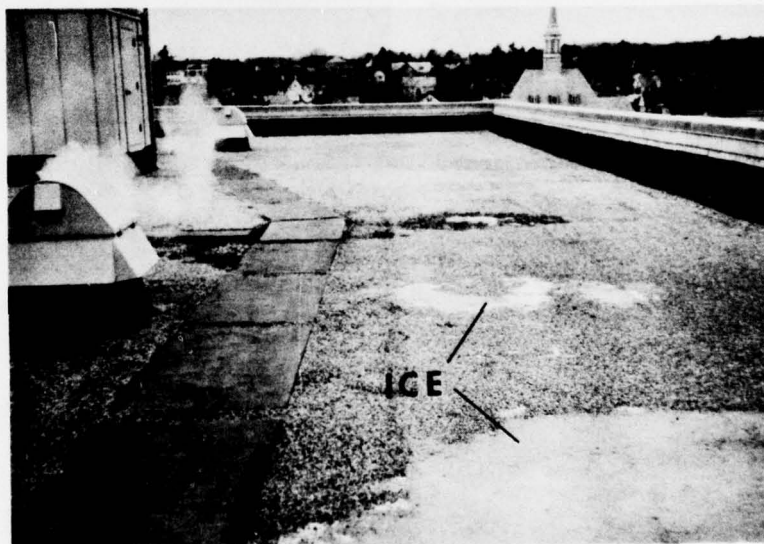
Figure 5. Thermogram showing mottled appearance of the State House Annex roof (1 – walkway, 2 – parapet, 3 – patches of ice, 4 – heat from exhaust fan).

Figure 6. Photograph of the area shown in Figure 5.

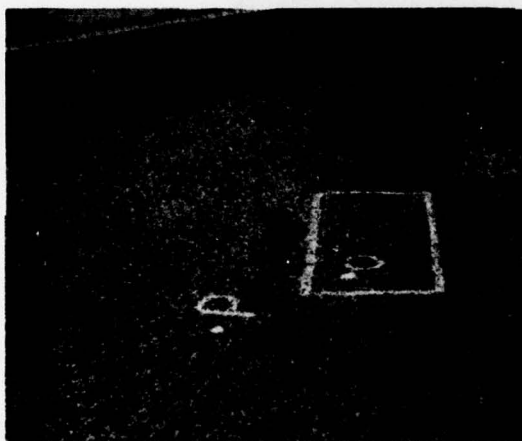
The following day the roof was sampled at locations O, P, Q, and S (Fig. 7). No insulation was present between the membrane and the deck. At point O, within the bright rectangular anomaly (Fig. 7), membrane plies were not well bonded and they delaminated easily. A layer of ice, $\frac{1}{2}$ in. thick, was present under the $\frac{3}{8}$ -in.-thick membrane as shown in Figure 9. A solid concrete deck was present below the ice. Chips of the concrete were found to have a density of 130 lb/ft³. Because of the unusual findings at point O, additional samples were taken on this roof. Nearby at point P (Fig. 8) no ice was found. However, $4\frac{1}{8}$ in. of granular fill resembling clinkers was present between the membrane and the deck. The top surface of the clinker layer

Figure 8. Outline of bright rectangular anomaly showing sample locations O and P.

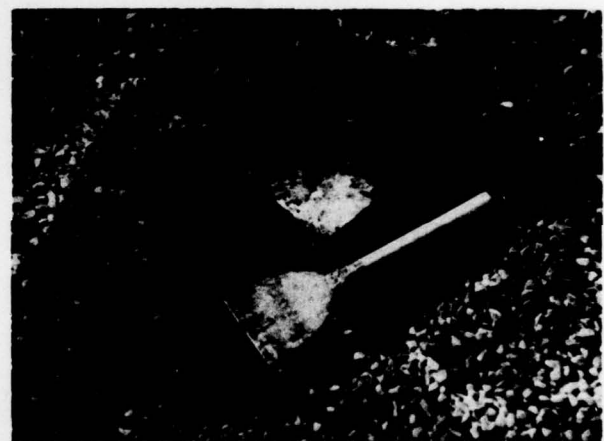
Figure 9. Ice $\frac{1}{2}$ in. thick was present under the membrane at point O.

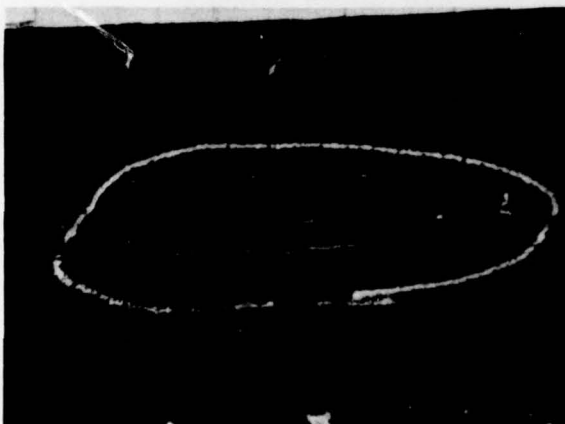
Figure 10. Flashing split circled in white spray paint. Fifteen such splits were located around the perimeter of this roof.

expected in the future. Such problems can be delayed somewhat by patching the numerous flashing flaws and eliminating other visible defects where water can enter the membrane.

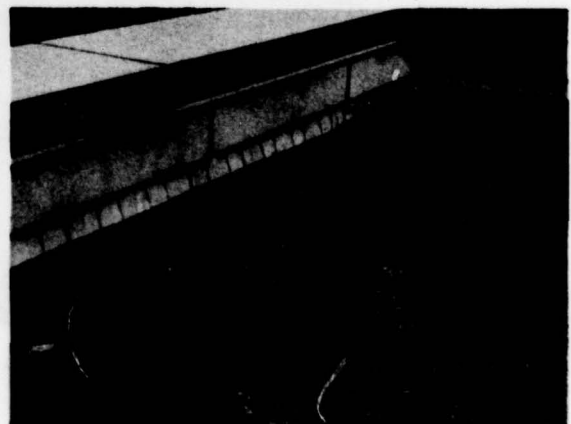
Figure 11. Damaged parapet wall counter flashing.

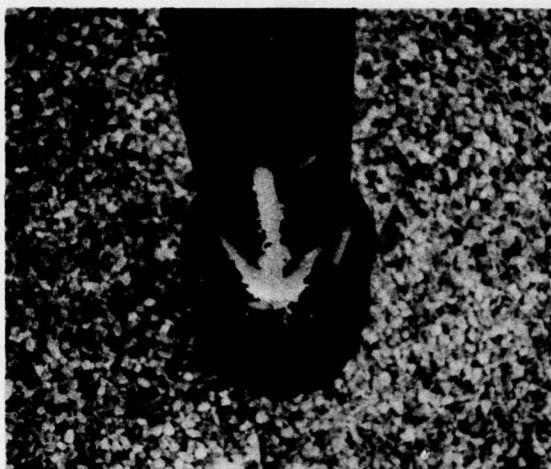
Figure 12. Cracked bitumen in a pitch pocket surrounding a vent pipe.

was lightly bonded with mortar to form a smooth substrate for the membrane. The clinkers were relatively dry, having a water content of only 4%. In the past, clinkers were used to provide slope for drainage of flat decks. The source of the ice at point O is not apparent. However, the deteriorated flashing around the building indicates that numerous points are available where water could get in under the membrane. Examples of flashing problems on this roof are shown in Figures 10 and 11. Other entry points for moisture are also present as shown in Figure 12. Portions of the roof are blistered.

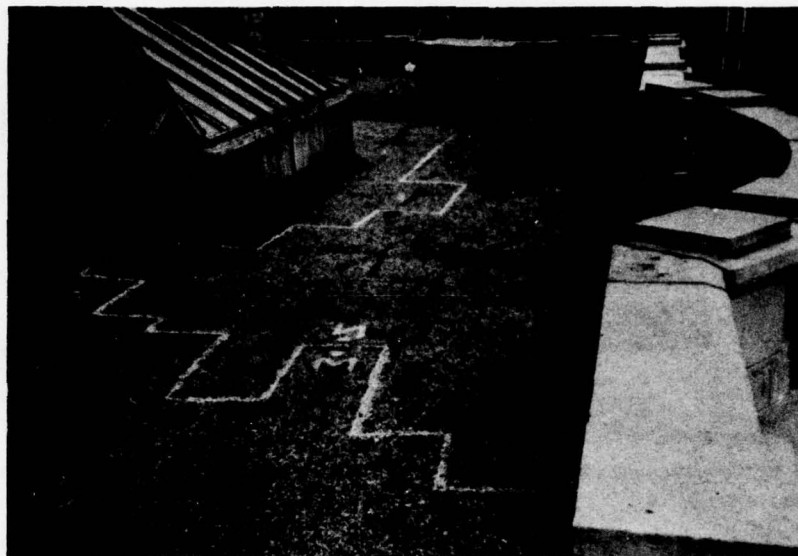
Figure 16. The area outlined in spray paint appeared darker than all other portions of the State Library roof.

The spray painted boundary in Figure 16 was stepped since it follows the edges of board stock insulation. Core samples of the 1 1/8-in.-thick wood fiber insulation at N and M had water contents of 32% and 211% respectively. Although insulation in the area represented by sample N was much drier than that of the rest of the roof, it contained enough moisture (32%) to seriously reduce its thermal effectiveness.

All of the insulation on this roof was either damp or wet and the membrane was dry, brittle and obviously not water-tight. Consequently the membrane and insulation should be removed and new insulation and a new membrane installed. Because the deck below the wet insulation is probably wet, it will be important to ventilate the new system to prevent trapped moisture from destroying the new membrane.

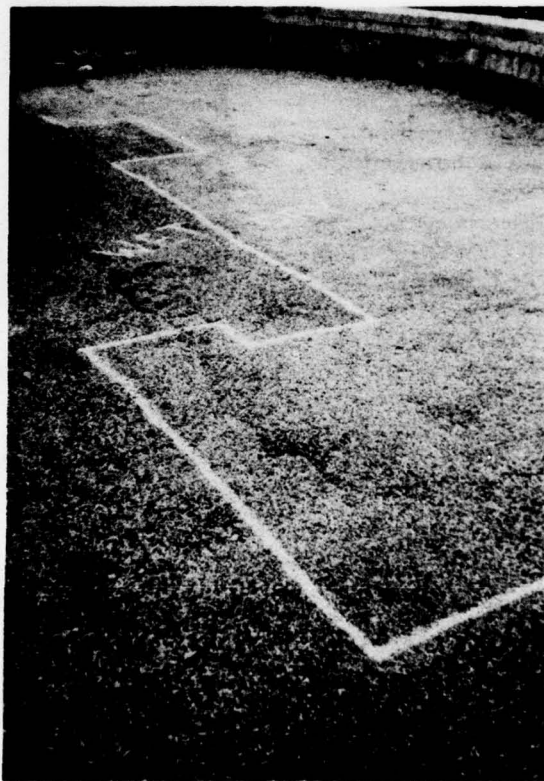
Figure 17. The spray painted area coincided with the area on which frost formed. This was the driest portion of the roof but the insulation contained enough moisture (32%) to reduce its thermal effectiveness over dry insulation.

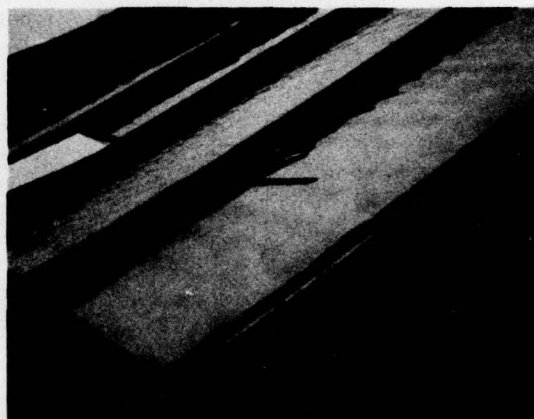
Skylight caulking was in bad condition (Fig. 20). Ample opportunities exist for water to enter the roof from that area. Major improvements to better seal the skylights will be required in conjunction with new roofing.

Figure 20. Skylight caulking needs repair.

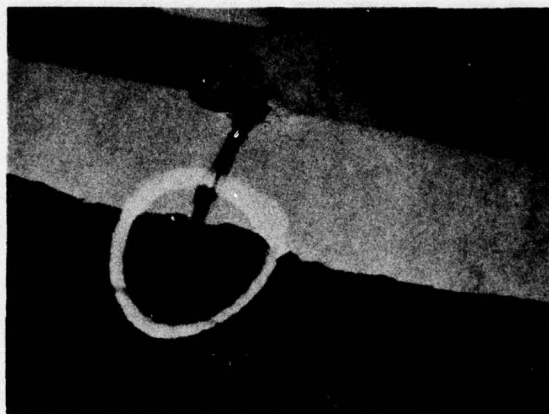
Figure 21. Mastic between the pieces of metal fascia has been split by thermal movements of the fascia, Legislative Office Building.

perimeter, movements of the sectional metal fascia had split the mastic at joints (Fig. 21). These locations were circled in white spray paint. In a few areas the splits extended down to the level of the gravel on the built-up membrane. A more reliable method of sealing the fascia should be devised to prevent entry of unwanted moisture and rapid deterioration of this currently excellent roof.

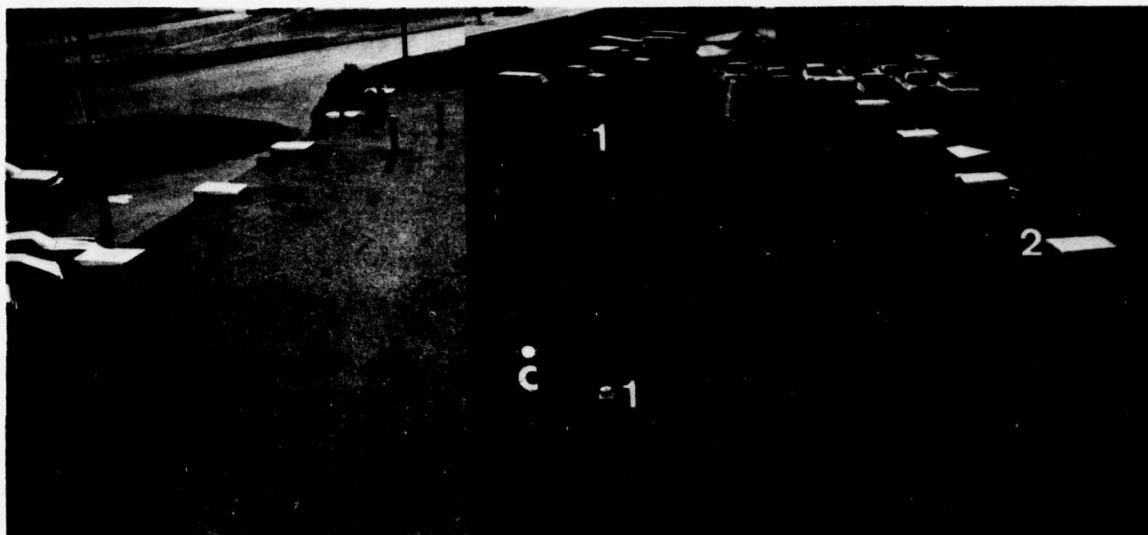
A panoramic view of level 3 was attained from level 2 (Fig. 23). A three-thermogram mosaic was also obtained from the same position (Fig. 24). The thermogram mosaic is mottled, fairly bright and contains dark lines which span the width of the roof. Large concrete beams under the roof insulation are the cause of the dark lines. They have caused the roof directly above

Figure 23. View of level 3, Highway Garage (1 — breather vents, 2 — typical cap where concrete frame protrudes).

Figure 24. Thermogram mosaic of level 3 (1 — breather vent, 2 — typical cap where concrete frame protrudes).

to be colder than the surrounding roofs. Two breather vents were installed in this roof when the membrane was replaced (Fig. 23). The vents were intended to dry out the light-weight vermiculite concrete insulation since it was known to be wet. However, there was no thermal indication that the light-weight concrete was drier around those vents than at any other place on that roof. Samples of the membrane and light-weight insulation were taken at points C and E. Water contents of the insulation were 32% and 40% respectively.

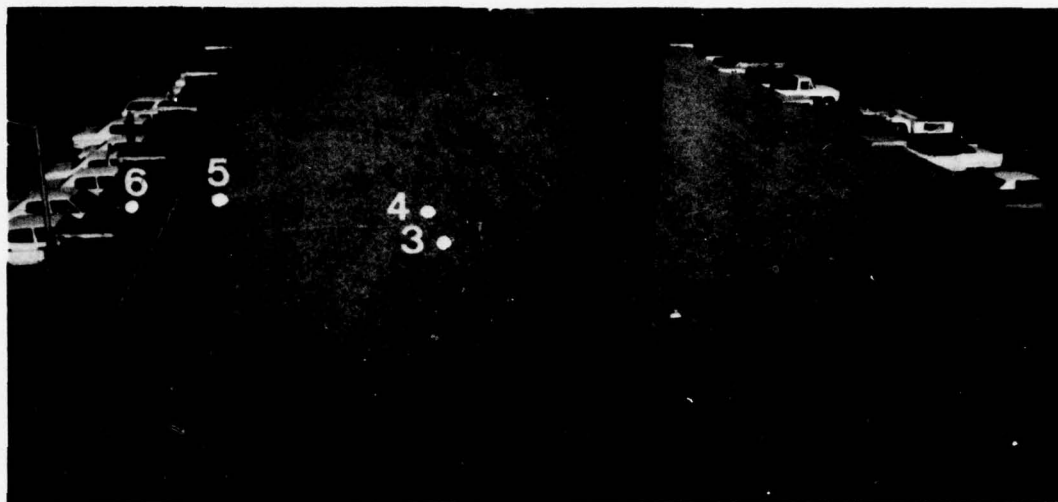
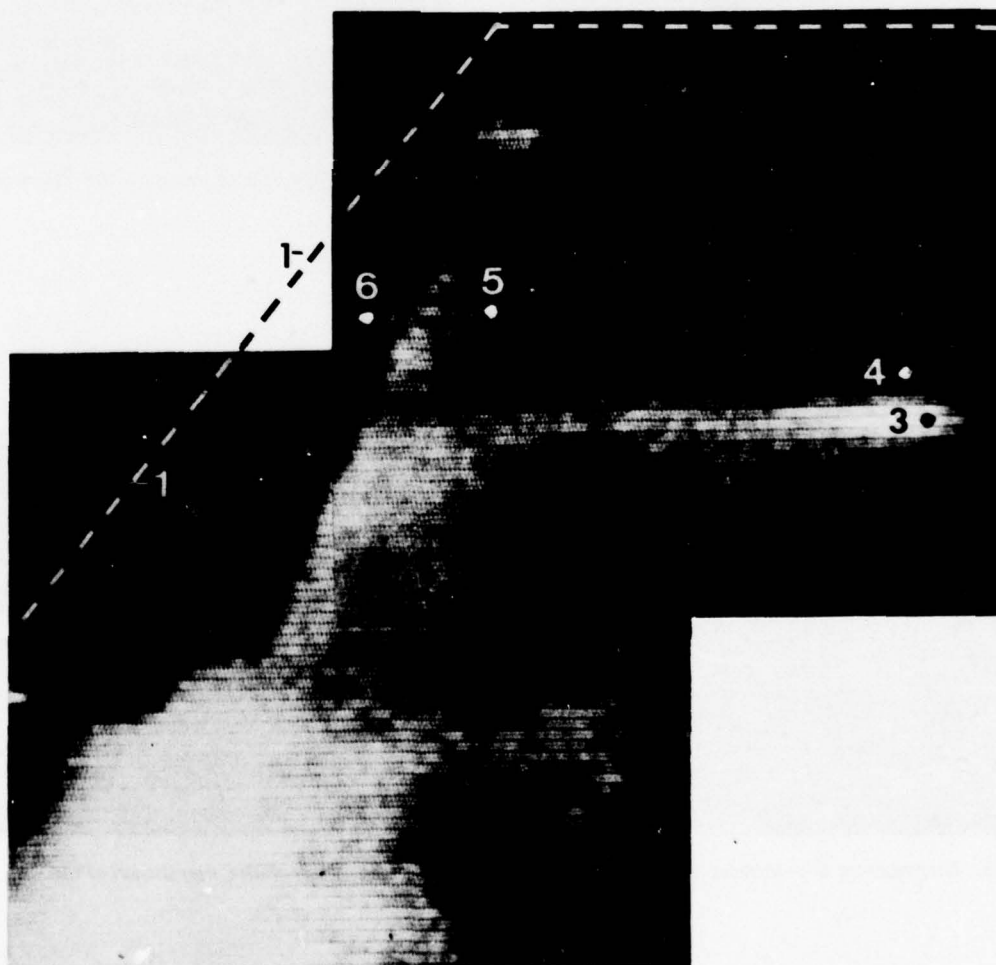
the thermogram (26) were also wet (113% and 68%, respectively). It was subsequently determined that the extra brightness shown in Figure 26 was caused by ceiling-mounted propane-fired heaters that were operating late in the evening when the infrared survey was conducted. On the thermogram, sample 6 is in a long rectangular black area. In that area the insulation was not light-weight vermiculite concrete but 2¼-in.-thick perlite. The perlite was rather dry (5%) and, as the dark area on the thermogram indicates, it was a far better insulator than the light-weight concrete insulation which is present on the remainder of the level 1 roof. A detailed view of the well-defined division between the thermal image of the dry perlite and the wet light-weight concrete is shown in Figures 27 and 28.

Figure 25. View of level 1, Highway Garage. Points 3-6 are sample locations.

Figure 26. Thermogram mosaic of a portion of level 1. Points 3-6 are sample locations (1 — edge of roof).

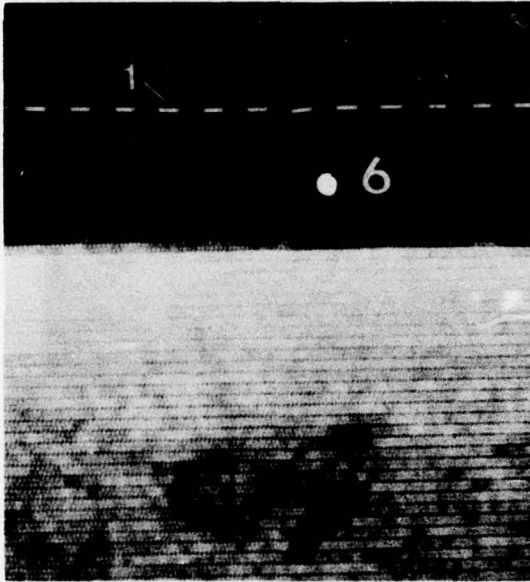
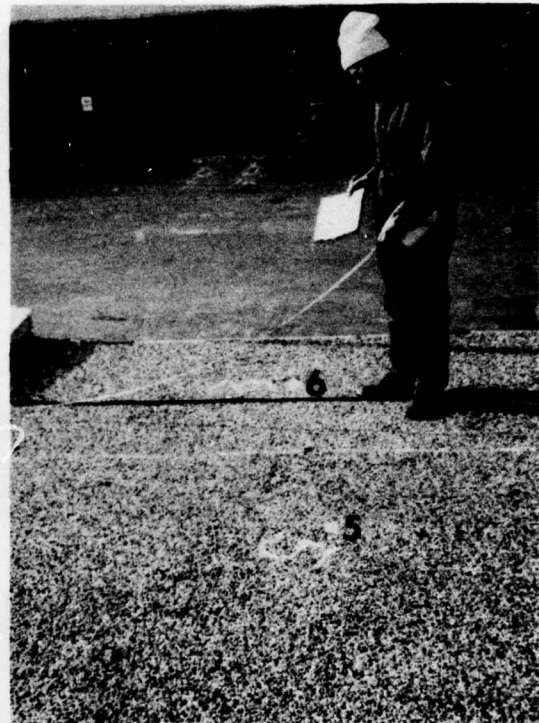
Figure 27. Thermogram of the boundary of light-weight concrete (bright area in foreground) and perlite board insulation (dark area in background) (1 — edge of roof).

Figure 28. View of area shown in the Figure 27 thermogram.

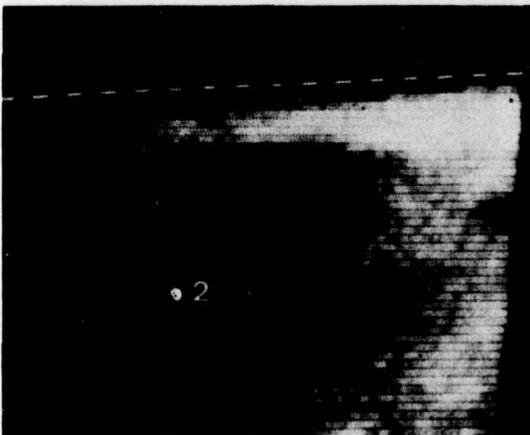
Figure 29. Thermogram of southeast corner of level 1.

Figure 30. View of the area shown in the Figure 29 thermogram.

Another thermal anomaly was detected by the infrared camera in the southeast corner of the level 1 roof, as shown in Figure 29. A conventional photograph of the same area is shown in Figure 30. It is believed that this anomaly is also related to propane-fired heaters suspended under the concrete deck. However, it is expected that the insulating concrete is wet throughout the area shown in Figure 29.

Although this level of the roof contains a large amount of moisture, it is apparently not causing problems to the occupants. Sometime before leaks develop to the point where equipment is in jeopardy or habitation of the building is impaired, a new roof will be needed.

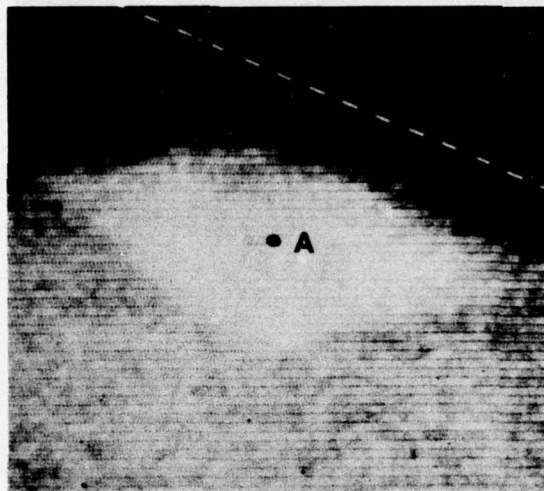
Figure 31. Thermogram of a small white anomaly near the northeast corner of level 4. Sample B was taken just beyond the thermogram's lower right corner.

Near the northeast end of the level 4 roof, a small white anomaly was detected. A thermogram and a conventional photograph of this area are presented in Figures 31 and 32, respectively. Water contents of the insulation at A and B were 130% and 28% respectively. At A the insulation was wet, black, decomposed

Figure 32. View of the area shown in the Figure 31 thermogram.

and compressed to a thickness of about $\frac{1}{4}$ in. At B the insulation was damp, light in color and $\frac{3}{4}$ in. thick. Based on the infrared survey, it is expected that the insulation at B represents the general condition over most of the roof in that area. Since the moisture content at B is rather high (28%), the insulation cannot be very effective thermally.

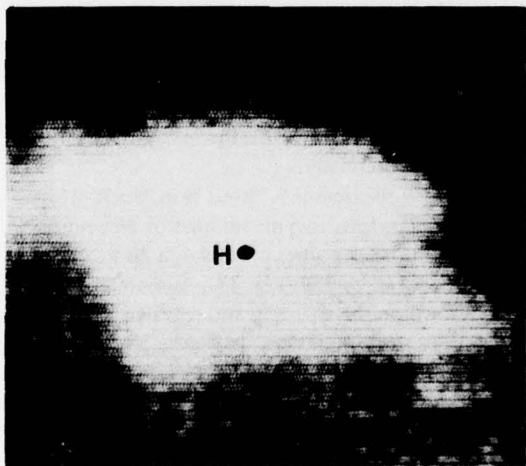
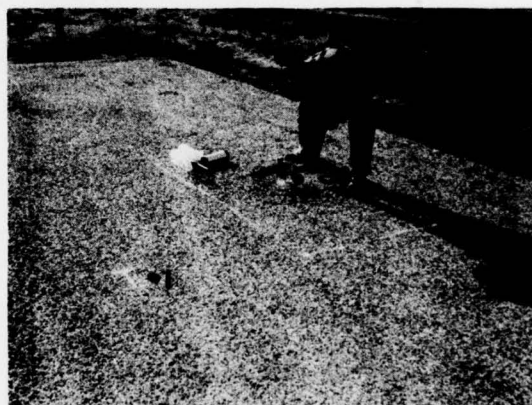
Several wet areas were found along the southerly portion of the west edge of level 4 (Fig. 22). A thermogram and a conventional photograph taken of one of the anomalies in this area are shown in Figures 34 and 35. Sample H, taken within the bright area of the thermogram, had a water content of 227%. Sample I, taken in the darker region nearby (Fig. 35), had a water content of 28%. No visible signs of membrane or flashing distress were evident in this area. Rainwater drains over a gravel stop at the eaves all along the nearby edge. It is speculated that snow meltwater, backed up on the roof by slight icings at the eave during the winter, found

Figure 34. Thermogram of the anomaly in the southwest corner of level 4. Sample I was taken just beyond the lower left corner of the thermogram in the gray area.

Figure 35. View of area shown in the Figure 34 thermogram.

its way into the roof through membrane flaws in this area. Over the eave drainage of essentially flat roofs in cold regions is seldom a problem-free situation.

rapidly. Although there is apparently no urgency to replace this roof because serious leaks are not present, a new roof and a significant amount of insulation should be considered before long.

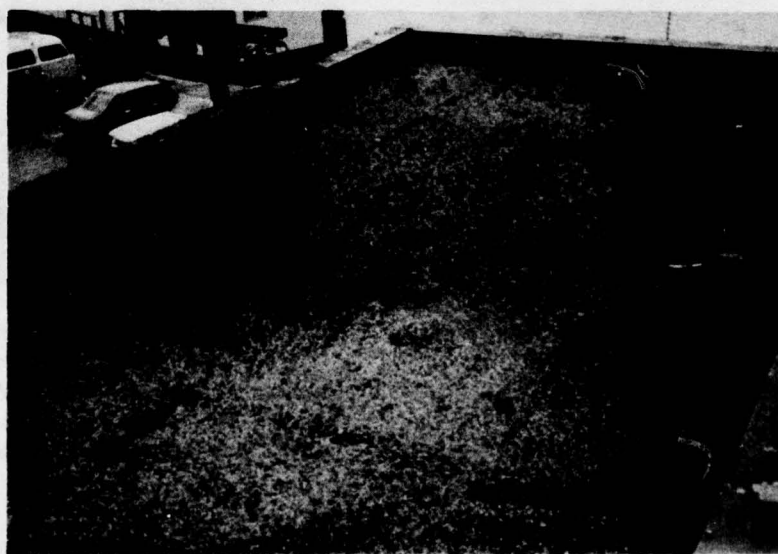
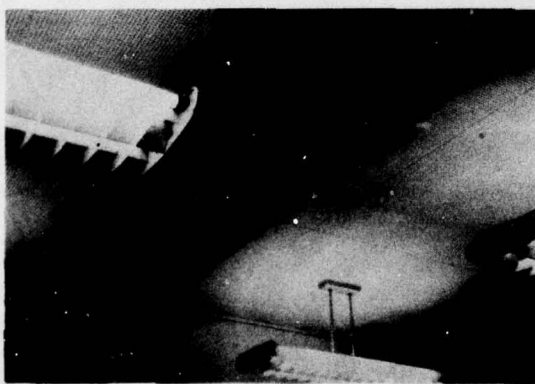
Figure 36. Thermogram taken on lower roof showing a regular pattern of stripes (1) and spots (2). The parapet is denoted by (3).

Figure 37. View of the area shown in the Figure 36 thermogram.

Figure 39. Ceiling under the area shown in Figures 36 and 37. The lights and beams can be "seen" in the thermogram (Fig. 36).

When the membrane on this building is replaced, it is suggested that internal vapor control be improved and an inch or more of board insulation be added above the wood deck to provide a more stable substrate for the new membrane.

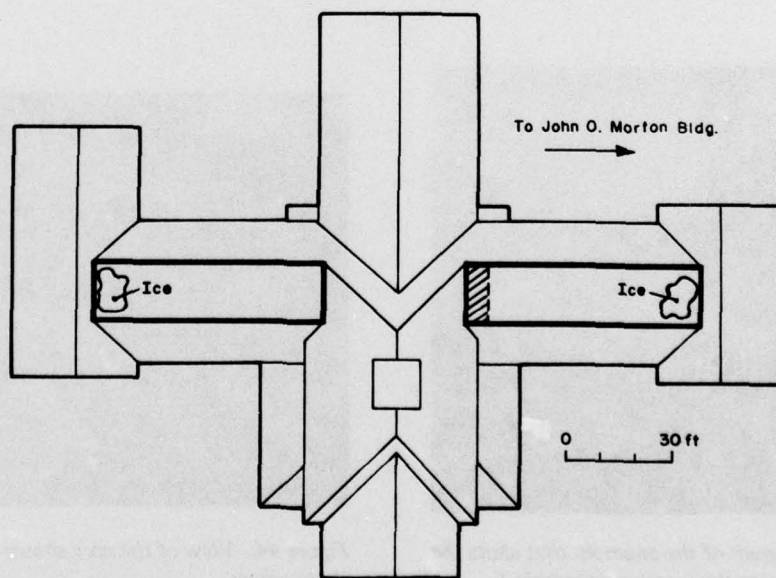
economically feasible to modify the two flat portions of the Supreme Court roof to better facilitate drainage. Since water and ice accelerate the deterioration of roof membranes, ponding should be avoided in future construction by providing adequate slope for drainage even on small areas, such as the two flat roofs of the Supreme Court.

Figure 41. Plan view of the Supreme Court with the outline of the two flat built-up roofs emphasized. The cross-hatched area was bright when viewed with the infrared camera.

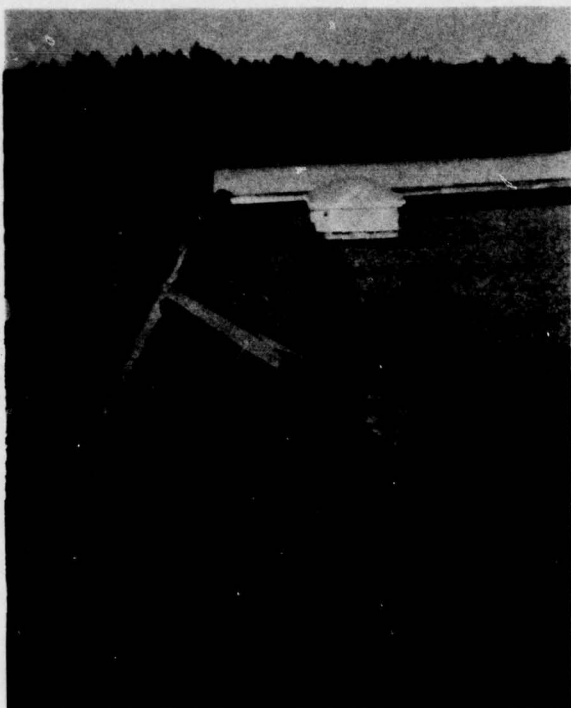
This building is only a few years old but is suffering from chronic roof leaks. Visually the gravel-covered membrane is in excellent condition. The only visible flaw on the roof is the displaced parapet wall cap flashing in one area (Fig. 47). The location of this problem is shown in the plan view of this roof (Fig. 48). This material should be repositioned as soon as possible.

Figure 47. Condition of parapet wall cap flashing on a portion of the Department of Health and Welfare Laboratory.

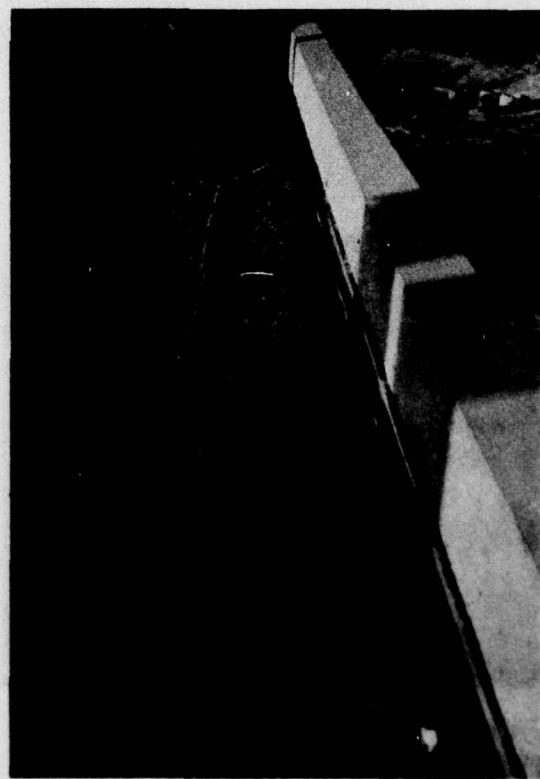
A comprehensive infrared survey of the roof uncovered three potential problem areas as shown in Figure 48. A thermogram and photograph of the first of these areas are shown in Figures 49 and 50. Insulation samples taken at A and B had water contents of 236% and 32% respectively. The perlite board insulation was

Figure 49. Thermogram of an anomaly along the parapet wall.

Figure 50. View of the area shown in the Figure 49 thermogram.

As an alternative to the above, the membrane, insulation, flashing and drain in the wet area could be removed and replaced as was recommended for the two wet areas of the John O. Morton Building.

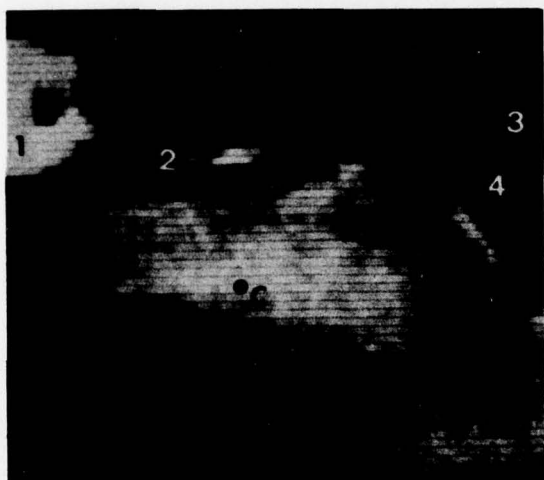
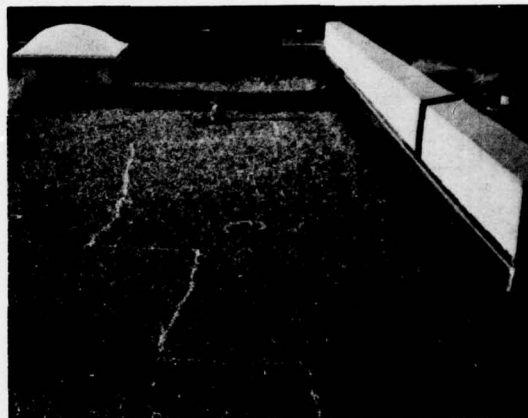
Figure 51. Thermogram of another anomaly along the parapet wall (1 – fan, 2 – drain, 3 – parapet, 4 – flashing).

Figure 52. View of the area shown in the Figure 51 thermogram.

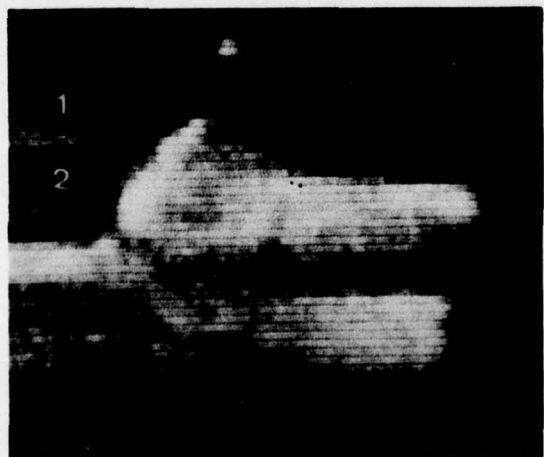
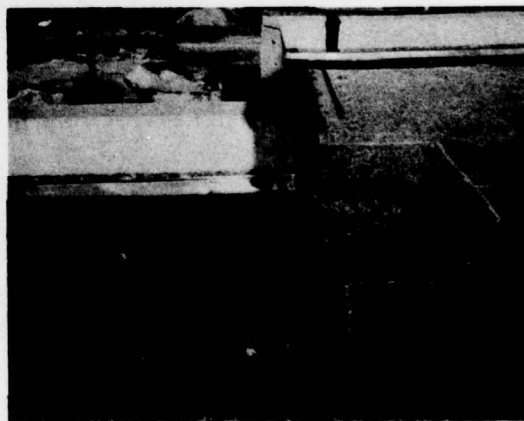
Figure 53. Thermogram of another portion of the anomaly shown in Figure 51 (1 – parapet, 2 – flashing).

Figure 54. View of the area shown in the Figure 53 thermogram.
